USDA-FOREST SERVICE

Date of Report: 9/6/2016 **Initial Request**

Blue Cut Fire – San Bernardino National Forest, Front Country Ranger District

BURNED-AREA REPORT
(Reference FSH 2509.13)

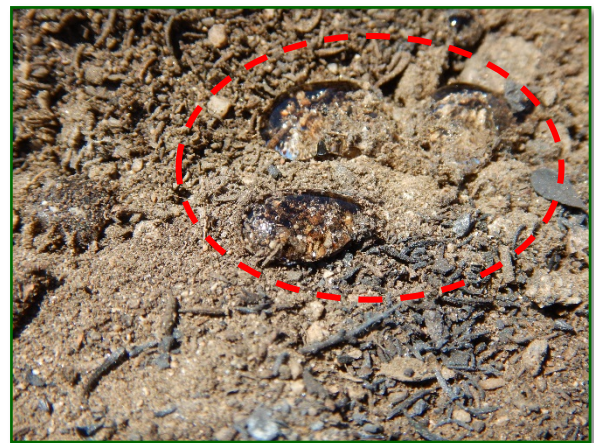
Figure 1: Strong soil water repellency

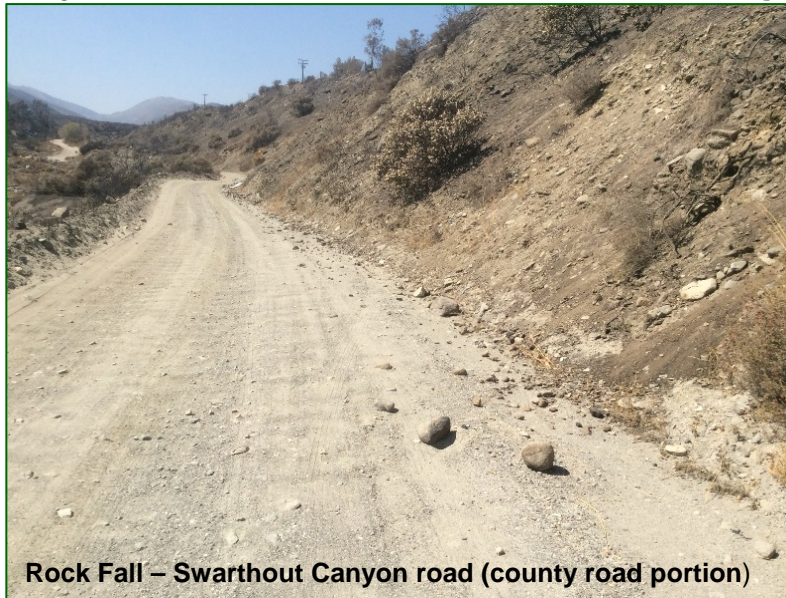
- Roads (Forest Service roads (3N06/3N49) Lytle Creek, Swarthout canyon and Lone Pine Canyon, Hwy. 66 (county), Hwy. 138 (State)): Rock fall occurred under pre-fire conditions below steep cuts and rock outcrop areas before the fire. County maintained Hwy. 66 is a 4 lane highway with the two lanes closest to the burned slopes closed. Rock fall is likely to occur in this area along the road. Rock fall will continue. The risk of rockfall and slope wash (dry ravel) along sections of these roads that burned is considered **High to Very High**.

Rock Fall – Swarthout Canyon road (county road portion)

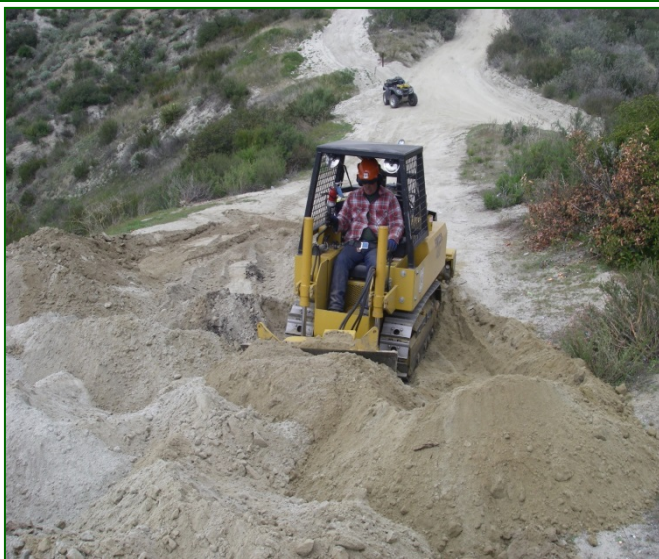
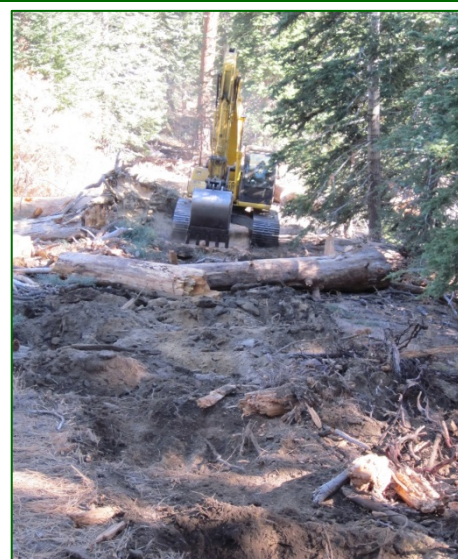
Above: Chunking with an excavator along a dozer line. After chunking, then the equipment spread topsoil and slash from the dozer piles over the treated area.

Chunking is described as using the bucket of an excavator or articulating blade on small trail dozer to de-compact unauthorized roads/trails by digging into the compacted area and creating divots (see below). These divots act as mini-catch basins (increasing infiltration), require minimal maintenance, and provide microsites for seed catchment and germination. In addition, container plants planted within the divots have high survival rates.
