USDA-FOREST SERVICE

Date of Report: 9/6/2016 **Initial Request**

Blue Cut Fire – San Bernardino National Forest, Front Country Ranger District

BURNED-AREA REPORT
(Reference FSH 2509.13)

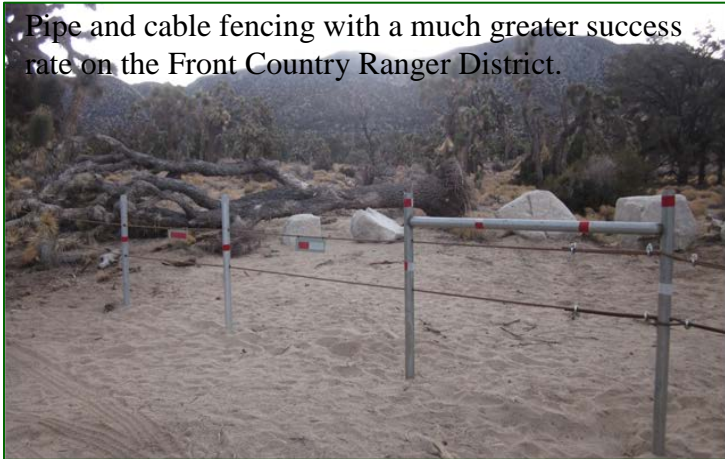
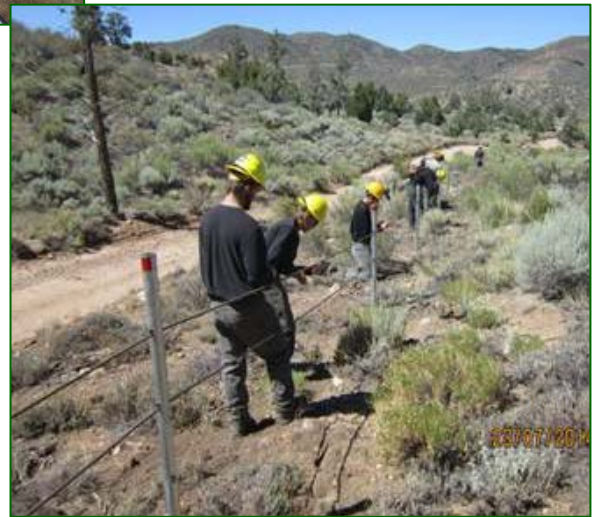
Pipe and cable fencing with a much greater success rate on the Front Country Ranger District.

In order to protect VARs from the increased OHV threat that is expected due to the lack of vegetation, the BAER assessment team has proposed four complementary OHV Resource Protection treatments to protect Values At Risk by installing barriers, gates, fencing, and vegetation barrier, using “chunking” to try to limit the amount of illegal cross-country vehicle, and increasing patrol presence. These four sub-treatments go hand-in-hand and the combination of them has proven effective in these high-OHV areas on the Front Country Ranger District. **Any one of these methods without the others, has less success and requires more follow up treatments.**
